RWS007

<b>ATAS INTERNATIONAL, INC</b> Allentown PA 610-395-8445 Mesa AZ 480-558-7210		TITLE	
		Perforated 7 Inch Box Gutter Screen Detail	
DWG. NO.	DR	DATE	
	KRK	1/3/2019	
MATERIAL	APP	DATE	
SH. SIZE	A	SCALE	X:X

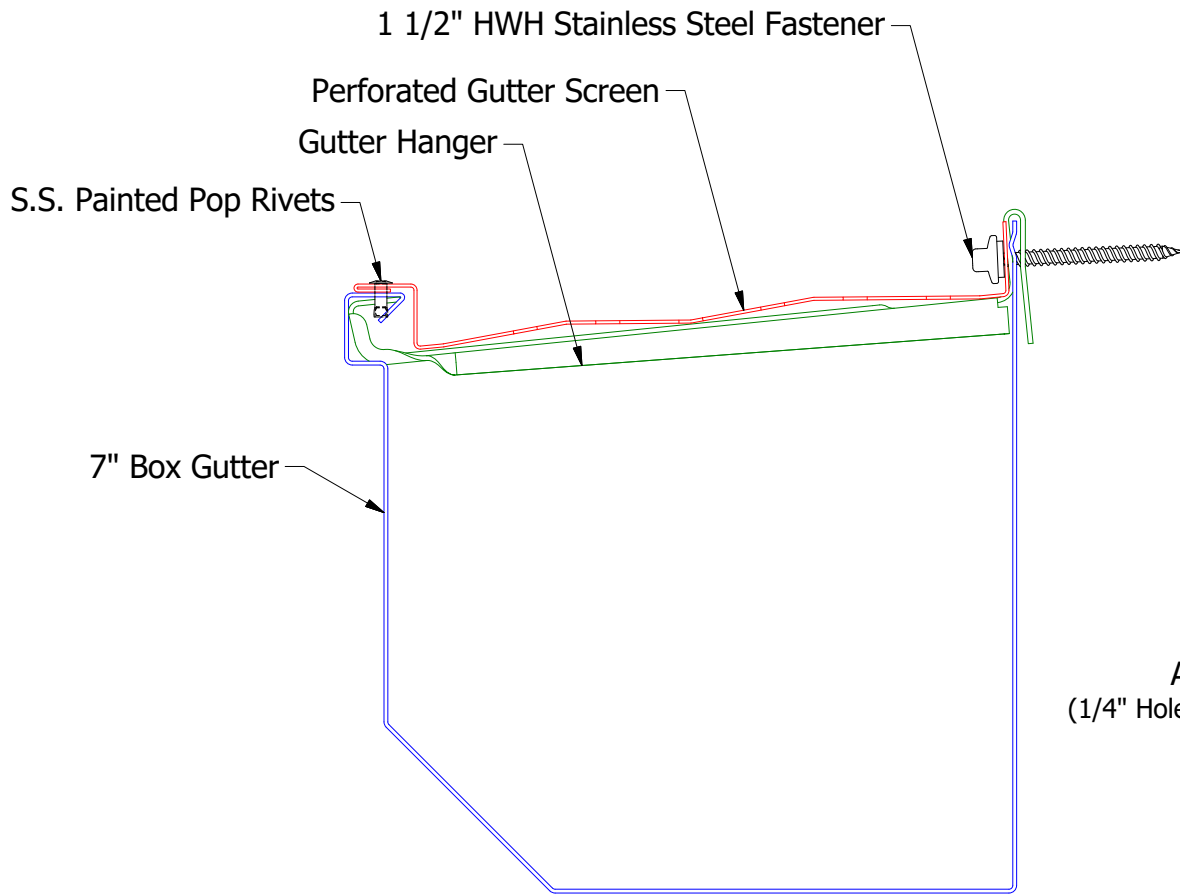
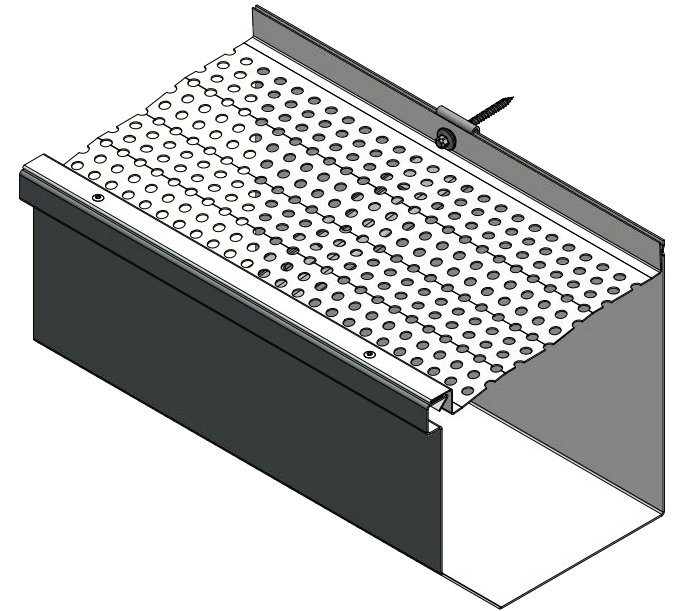
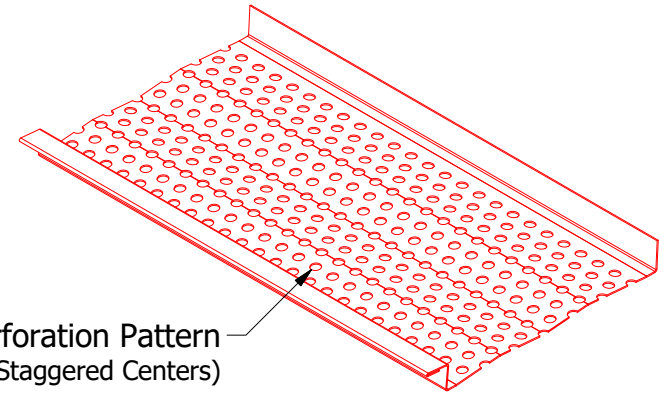
A23 Perforation Pattern  
(1/4" Holes, 1/2" Staggered Centers)

Note: Perforated Gutter Screen comes painted White.
